# DIVERTING RESERVOIR DAM

## PHASE I INSPECTION REPORT

NY 00056

Name of Dam: Diverting Reservoir Dam  
County and State: Putnam County, New York  
Inventory Number: NY 00056

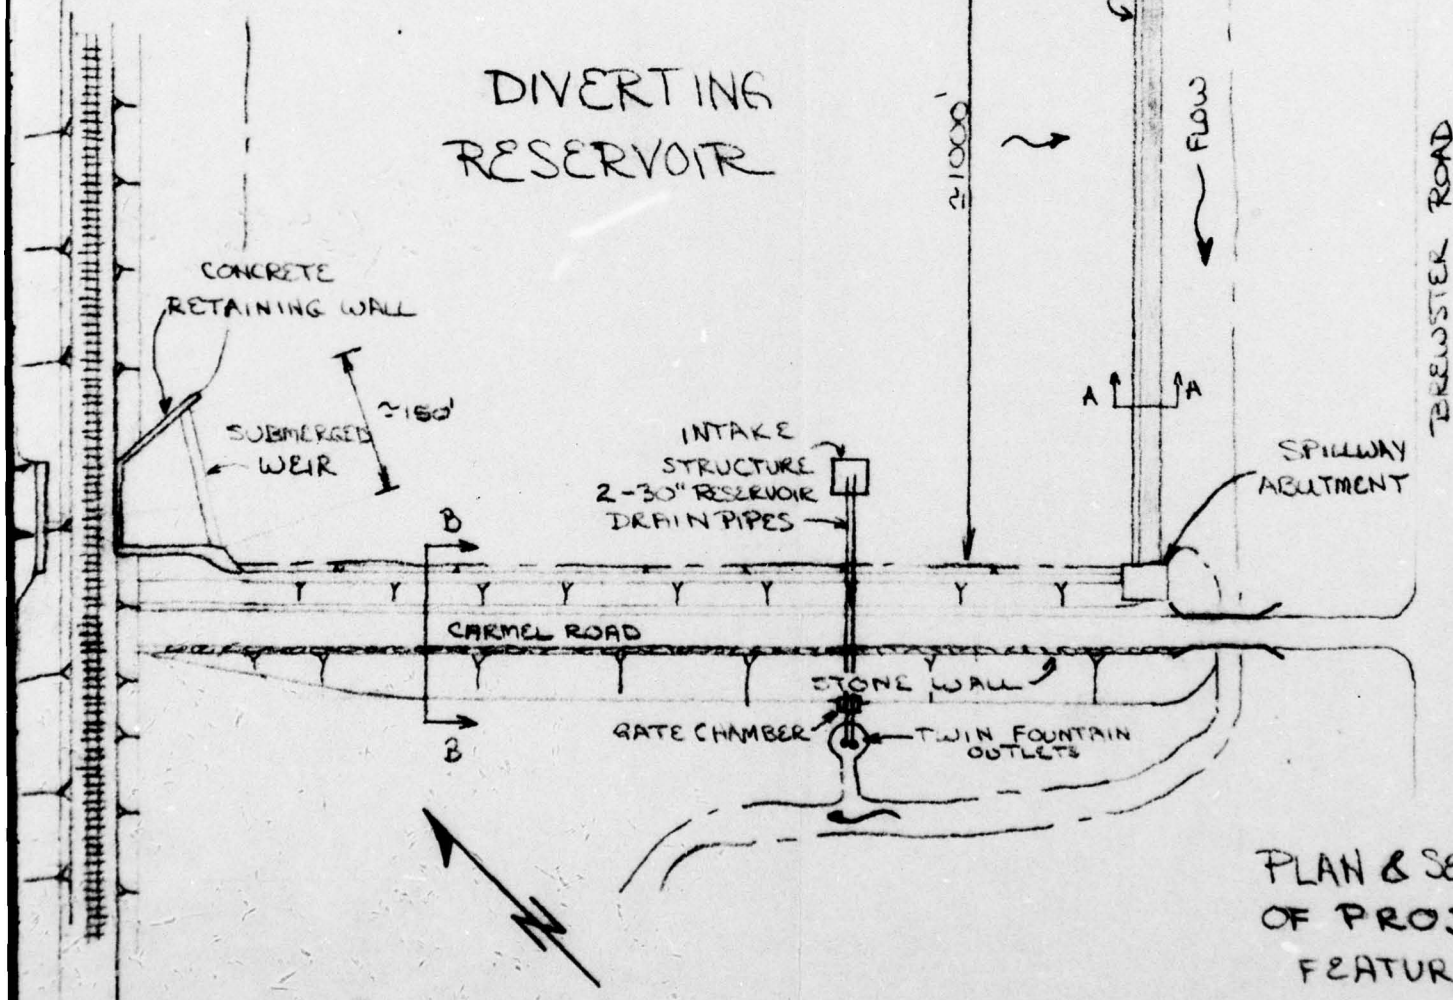
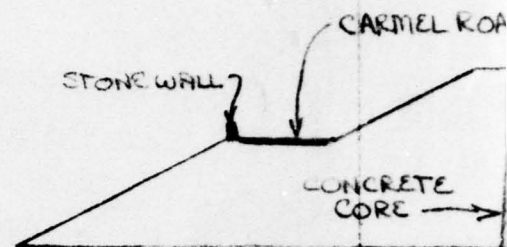
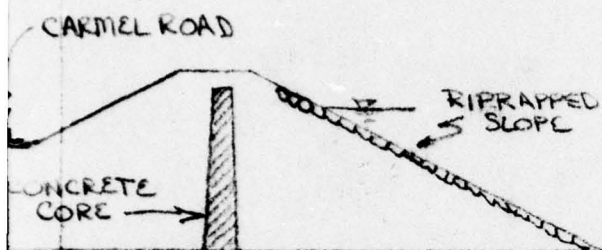
FIGURE 5

No indications of instability were observed during the visual inspection of the Diverting Reservoir Dam. However, review of the stability analyses for the spillway indicates that adequate factors of safety are not present under the loading associated with the PMF: the foundation reaction is outside of the middle third of the base for all loadings analyzed. Strengthening of the dam to provide adequate factors of safety is recommended.

The earth embankment is constructed perpendicular to the spillway, as shown on Figure 5. The horizontal and vertical alignment appear to be good. Riprap slope protection for the upstream face consists of large, near rectangular stone (12 to 15 cubic feet), set in place with smaller angular stone and gravel wedged between the large stone. The riprap appears in excellent condition. Brush was noted at several locations near the top of the upstream slope. A concrete retaining wall is constructed along the earth embankment near the railroad embankment. The wall extends about 100 feet along the railroad embankment and along the reservoir shoreline for about 150 feet as shown on Figure 5. Mr. John Birrell stated that a broad crested weir is constructed from the ends of the retaining wall. Mr. Birrell said that the weir is about 150 feet long, with the crest elevation about 5 feet below the normal pool.

The lower slope of the embankment is heavily overgrown with small trees and brush. No saturated areas, standing water, movement of embankment materials, or misalignments were noted on the embankment or near the toe.

The gravity overflow section should be strengthened to provide adequate factors of safety for extreme loading conditions. This could be accomplished by making the structure more massive, or by the installation of post-tensioned tendons through the structure.
